# BIG SEWICKLEY CREEK WATERSHED ASSESSMENT, RESTORATION, & PROTECTION PLAN

OCTOBER 2010

BIG SEWICKLEY CREEK  
WATERSHED ASSESSMENT, RESTORATION, AND PROTECTION PLAN

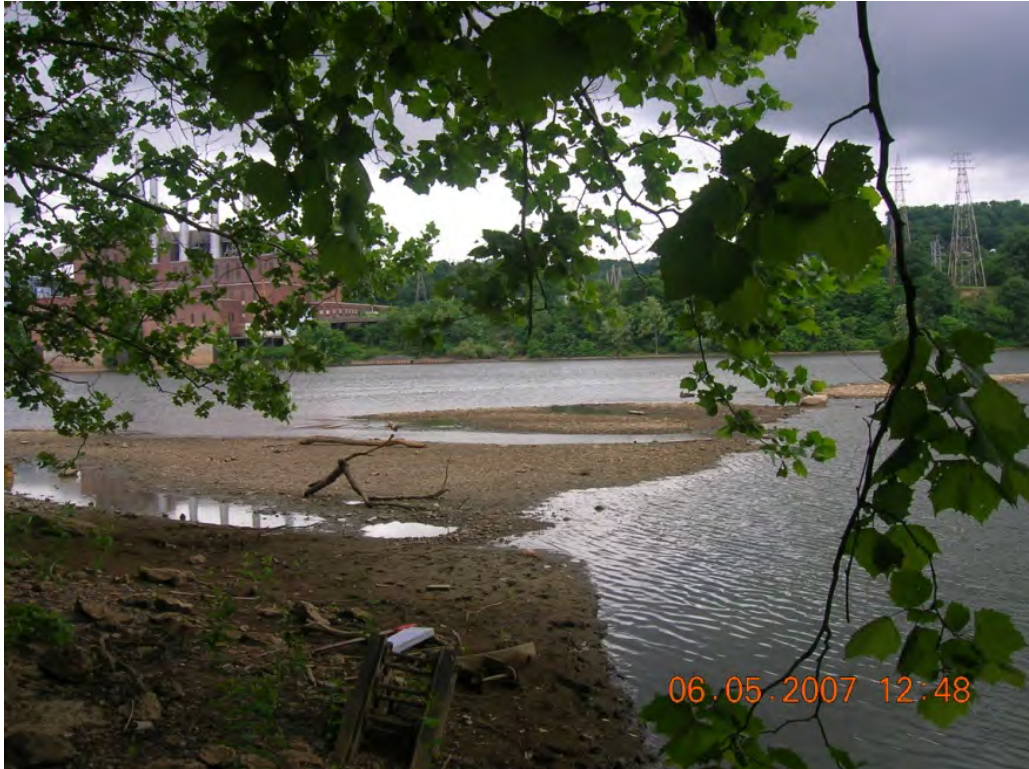
Photo 1: Mouth of Big Sewickley Creek, discharging into the Ohio River. (BSC-01)

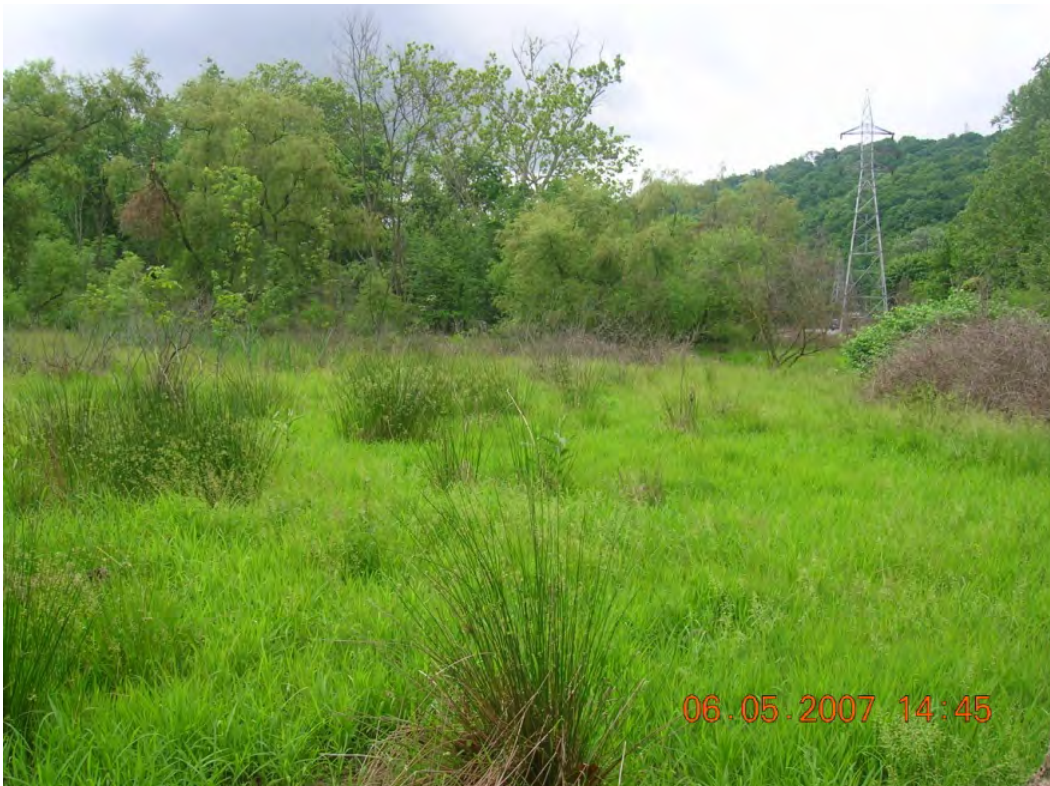
There is about 1 acre of wetlands (see photo 2 and Figure 6) located along this area of the Big Sewickley Creek.

Photo 2: Large floodplain wetland upstream from the mouth. (BSC-08)

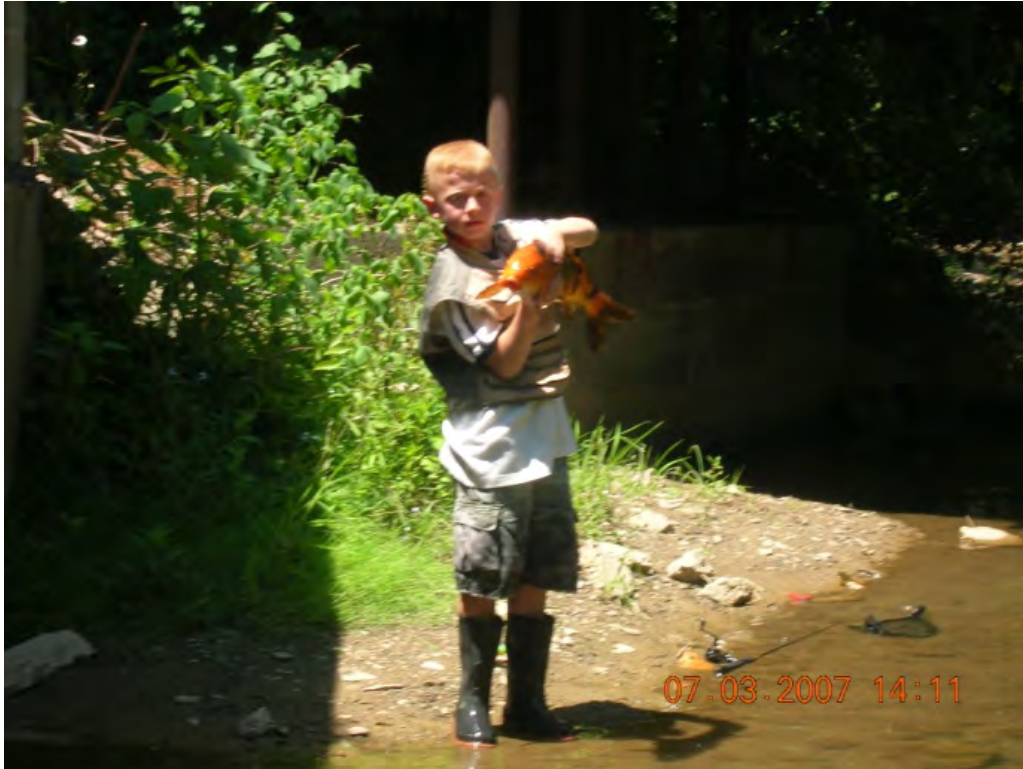
There is a white discharge seen coming out of the creek bank (see photo 5). BAI is not sure what was causing this discharge. Often times white discharges are indicative of aluminum in abandoned mine water. Fisherman Kevin Holman is seen showing off his catch of an orange koi (see photo 6). It should be noted that this species is invasive.

Photo 6: A local boy catches an orange koi. (BSC-41)

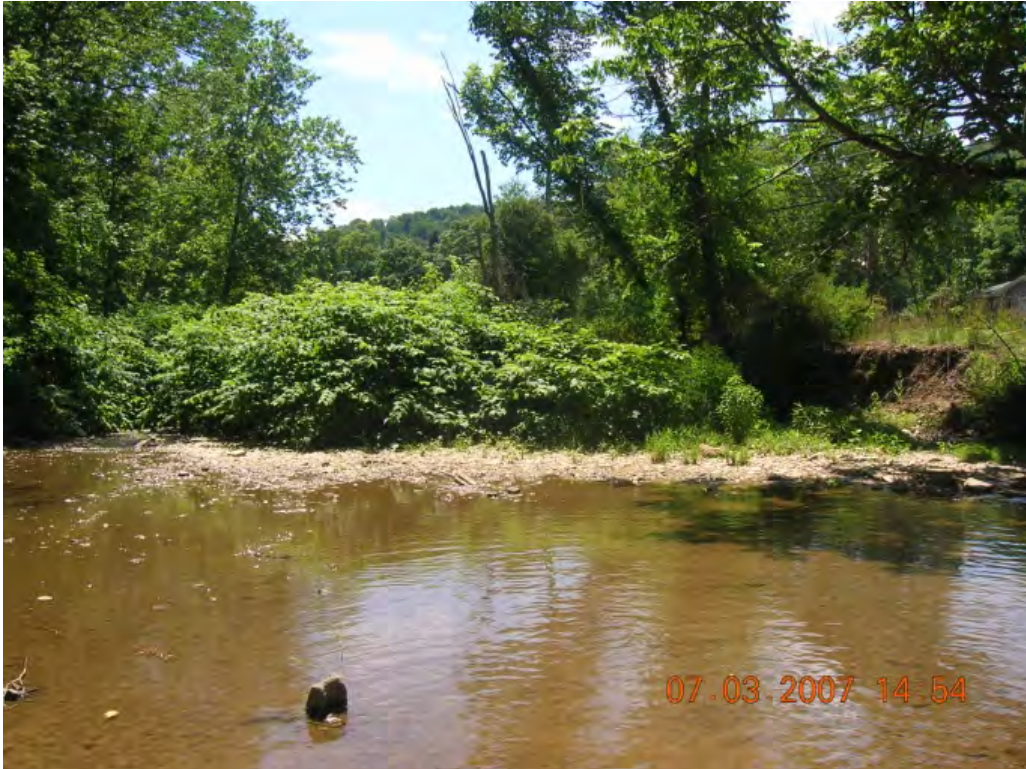
Photo 2: Sediment bar built up in middle of stream. (BSC-45)

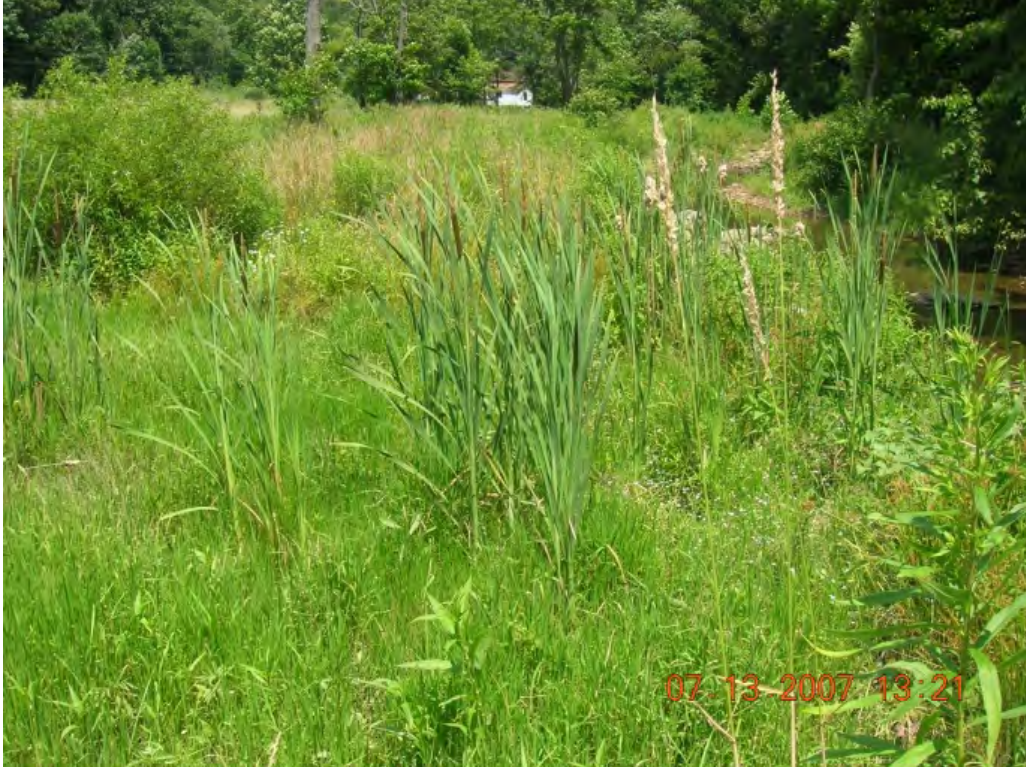
Photo 2: Floodplain wetland area. (BSC-61)

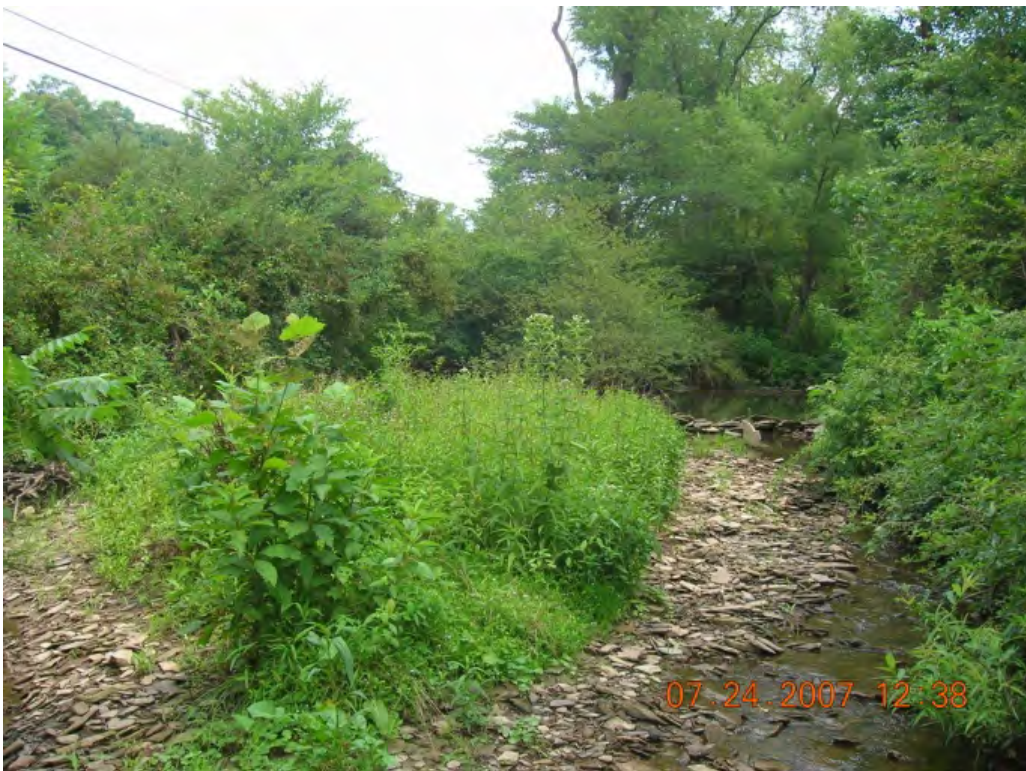
Photo 3: Large sediment bar built up in middle of stream. (BSC-69)

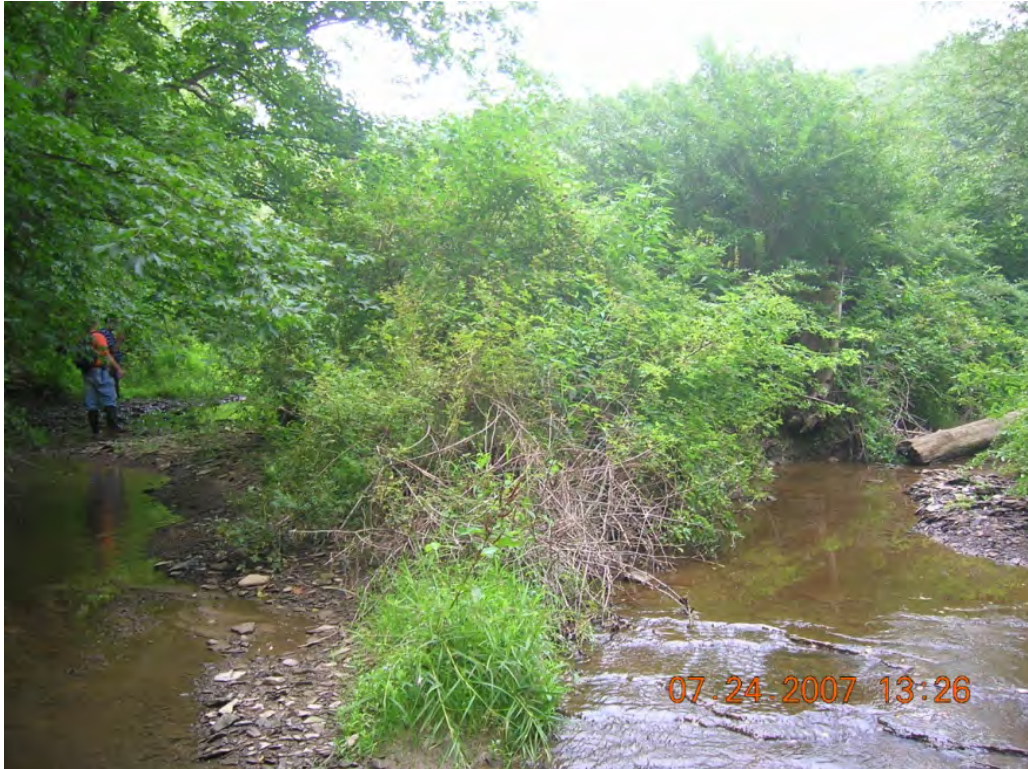
Photo 1: Large sediment buildup in the middle of the stream. (BSC-74)

The eroded stream banks should be stabilized or stream channel restoration work could be done to direct the flow into the middle of the channel and away from the stream banks. There could be a nice area for a streambank stabilization project at BSC76.

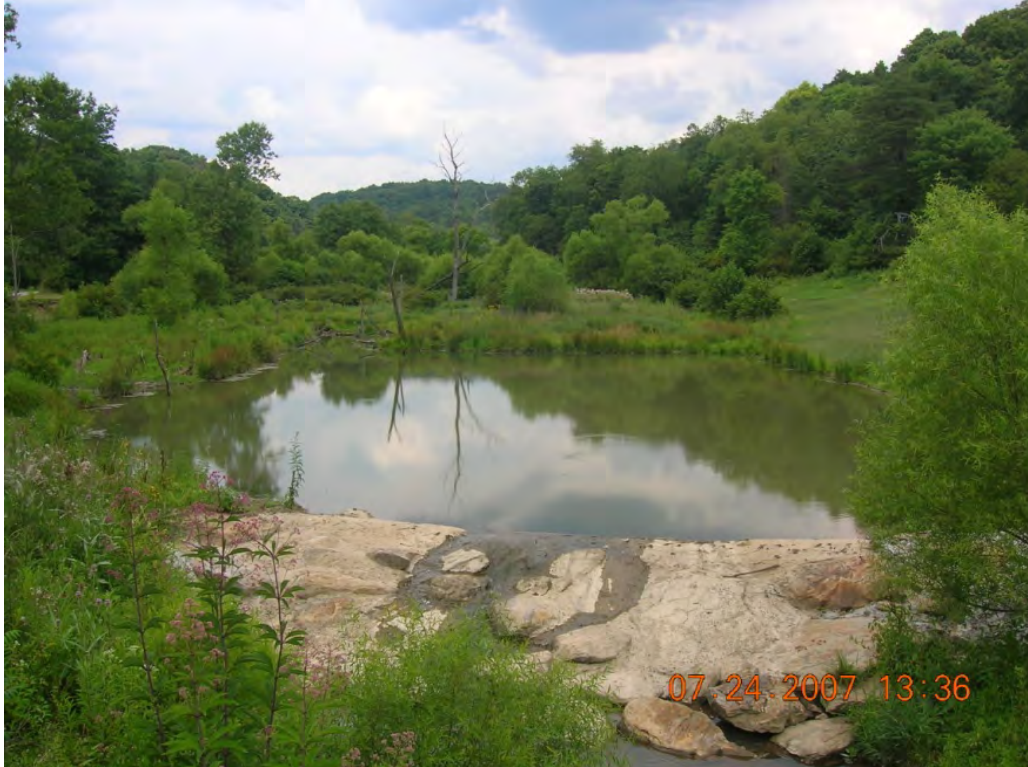
The debris jams along with the on stream pond at Markman Road act as fish barriers, preventing fish to travel past them.

Photo 3: An on-stream pond and wetland area near Markman Park Road. (BSC-76)

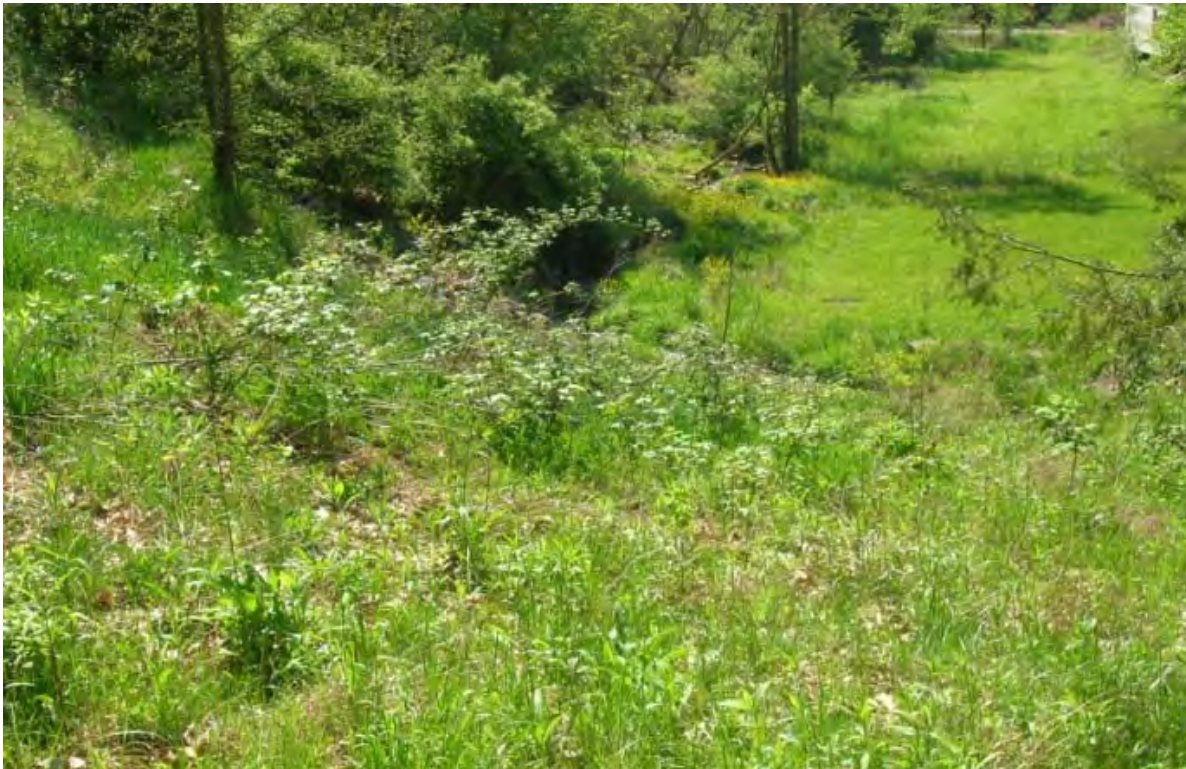
Photo 2: Upstream, this tributary has a good riparian zone. (BSC-T3W3)

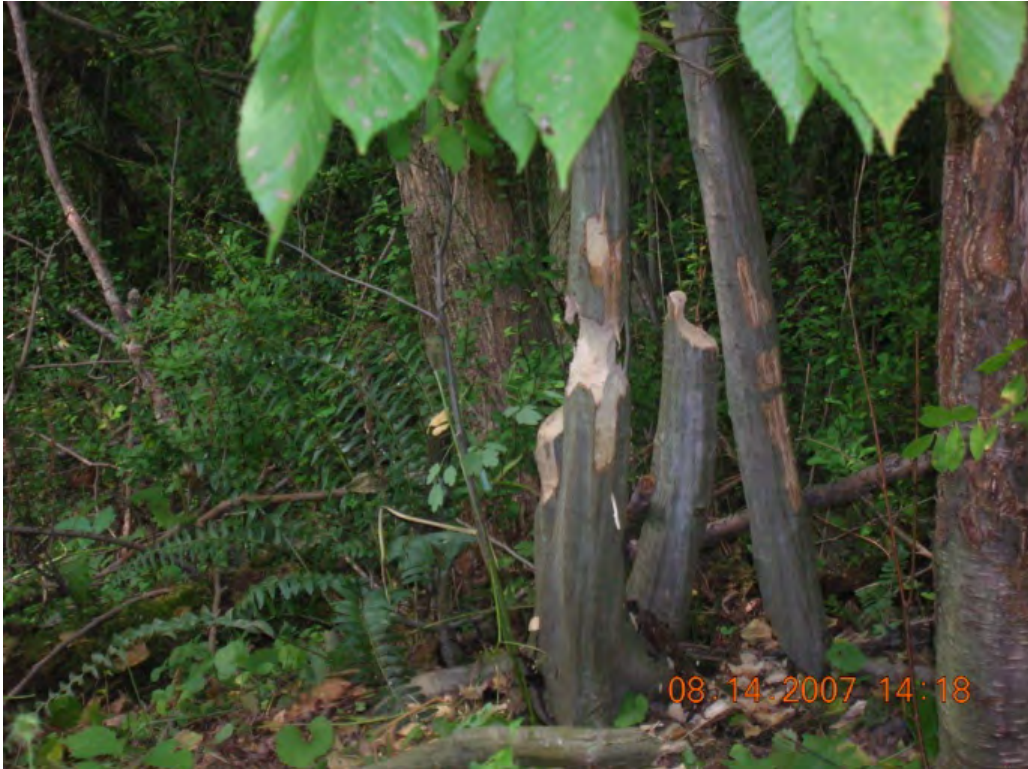
Photo 4: Sign of beaver activity near the stream. (EF-19)

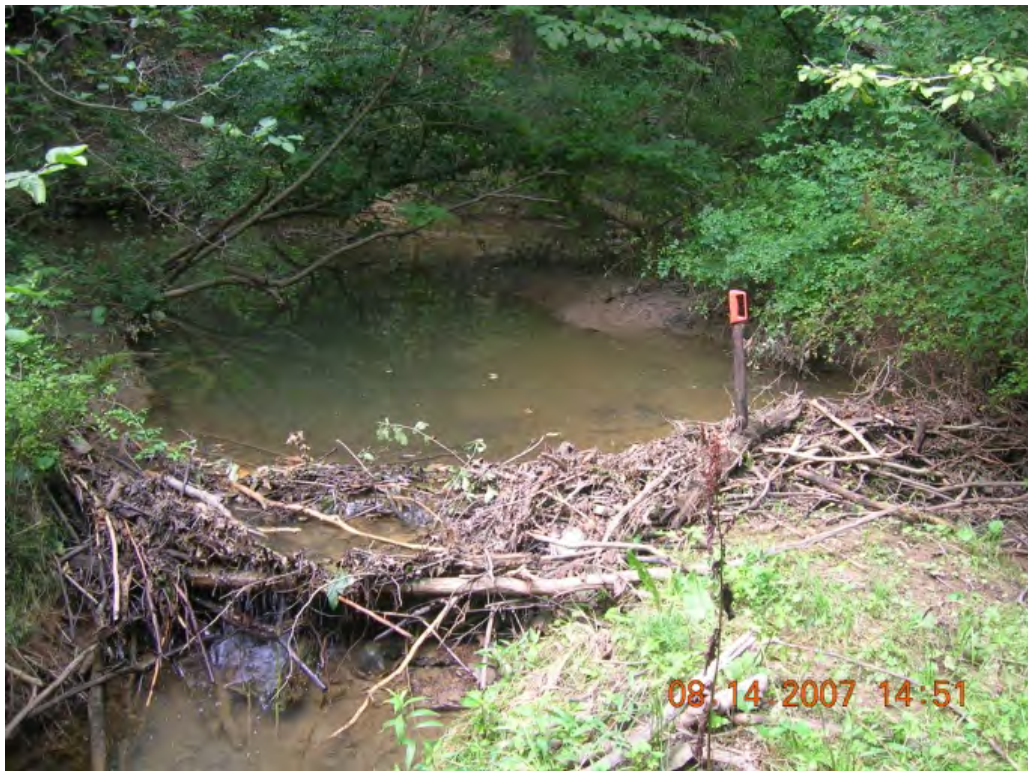
Photo 5: Upstream from the beaver activity, this small dam was observed. (EF-20)

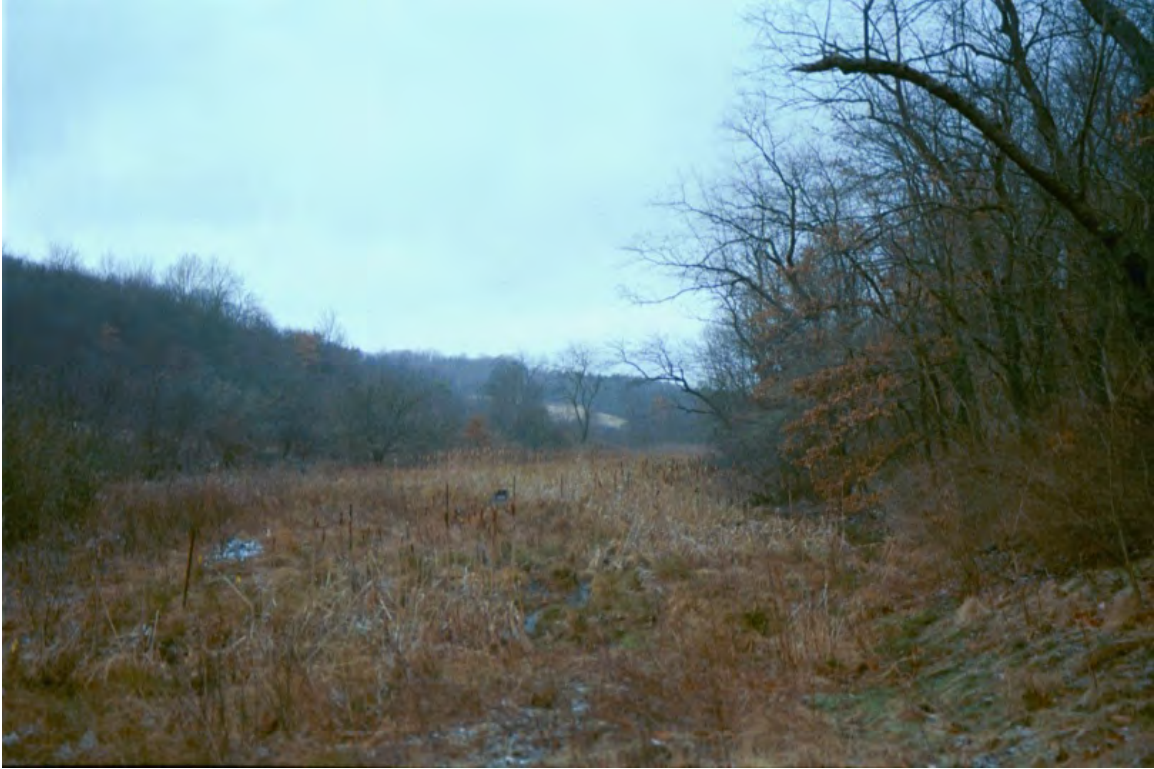
Photo 1: Floodplain wetland area. (NF-T5W3)

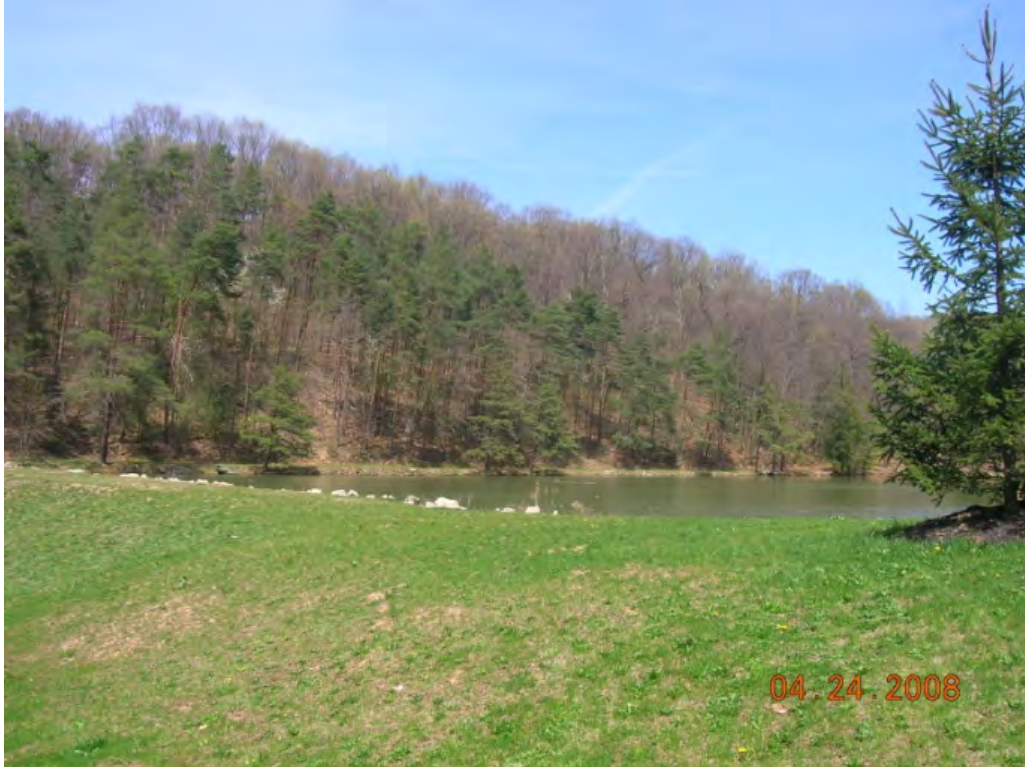
Photo 3: Sechlers Lake, which Rippling Run flows through. (RR-09)

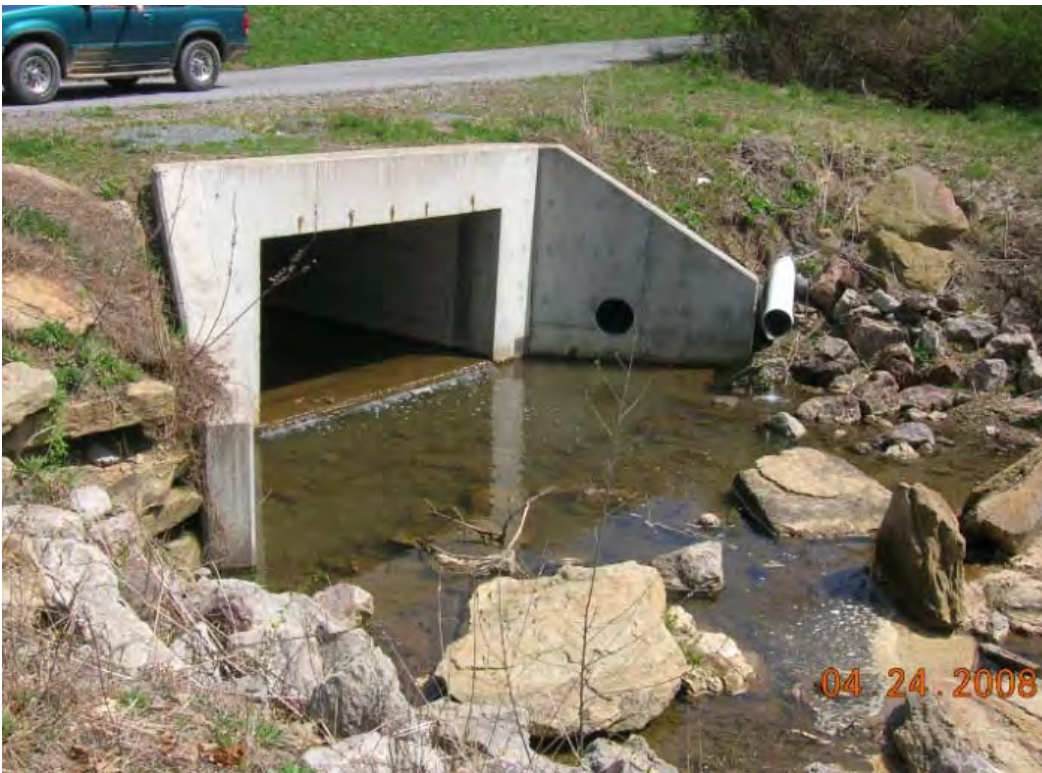
Photo 4: Outlet to Sechlers Pond. (RR-09)

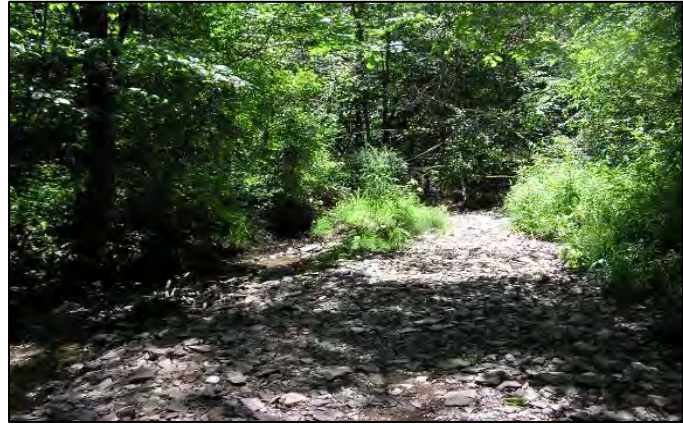
Site 7 is located north off Markman Park Road and was accessed through trails within a State Game Land. This site was only sampled for macroinvertebrates. The stream is approximately ten feet in width and the substrate is composed of silt and gravel.

Figure 19 exhibits the water chemistry analysis. This site had the lowest level of conductivity and one of the four lowest levels of turbidity. The water chemistry analysis summary can be found in Figure 26 (Page 21).

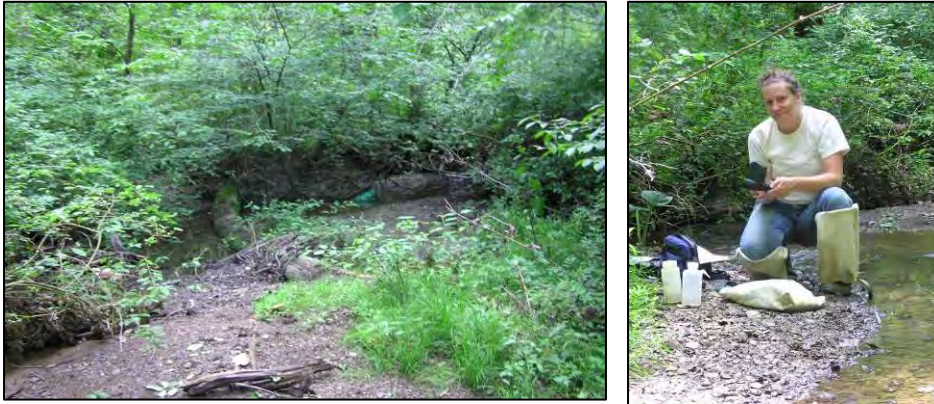
**Site 8:** EF 29-30 GPS: N 40.62559 W 80.10851

Site 8 is located adjacent to a State Game Land’s access area and is parallel to Interstate 79. This site was only sampled for macroinvertebrates. The stream is approximately eight feet in width and the substrate is composed of cobble, gravel, and silt.

Figure 21 exhibits the water chemistry analysis. This site had one of the two lowest pH levels of 7.80. Conversely, this site also has the highest levels of; total dissolved solids, conductivity, and nitrates. The water chemistry analysis summary can be found in Figure 26 (Page 21).
