**PINE CREEK WATERSHED
CHANNEL and RIPARIAN ASSESSMENT
and
RESTORATION PLAN**

NORTH AREA ENVIRONMENTAL COUNCIL
in partnership with the
PINE CREEK WATERSHED COALITION

ALLEGHENY COUNTY, PENNSYLVANIA

March 2010

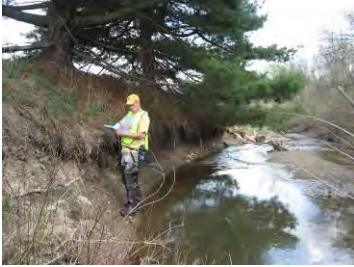
There are a number of erosion undercuts threatening substantial trees that are holding the streambank. These trees could block the channel if they fell into the stream.

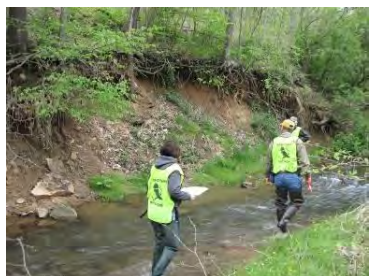
Erosion and tree undercutting just off S. Montour Rd.

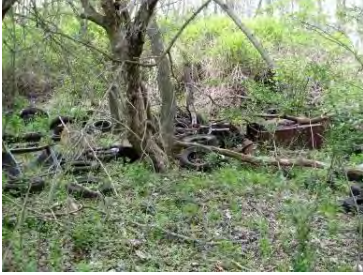
Several sights had old deposits of machinery, or debris. This is a large tire dump with assorted appliance pieces.

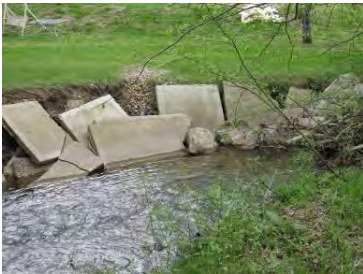
Efforts to armor stream bank with concrete slab are not completely effective.

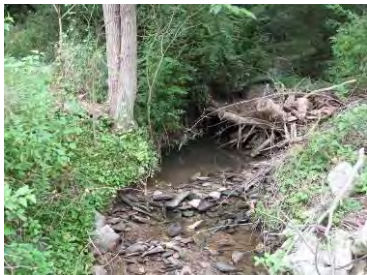
Debris can be caught against culverts in high flow event, creating dams.

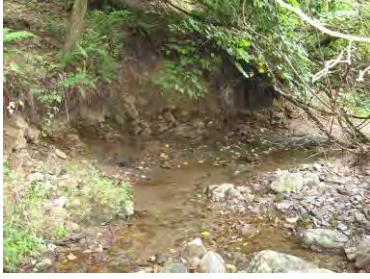
The constricted channel contributes to erosion of steep banks.

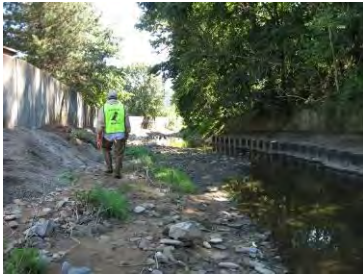
The lower reaches of West Little Pine have received large volumes of sediment from the upper portions of the watershed during storm events. In some areas the deposits have become problematic because they reduce the capacity of the constricted channel during high flow events.
