South Fayette Visual Watershed Assessment

August 2013

**South Fayette
Watersheds Visual Assessment**

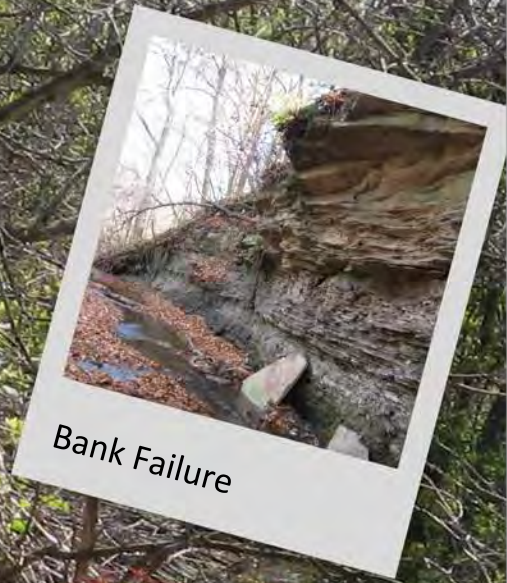
Bank Failure

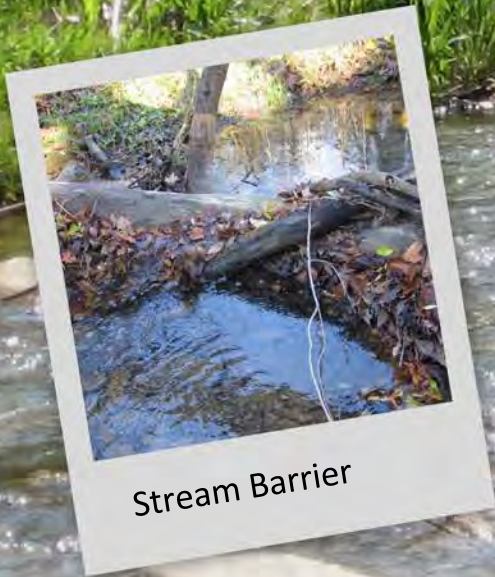
Stream Barrier

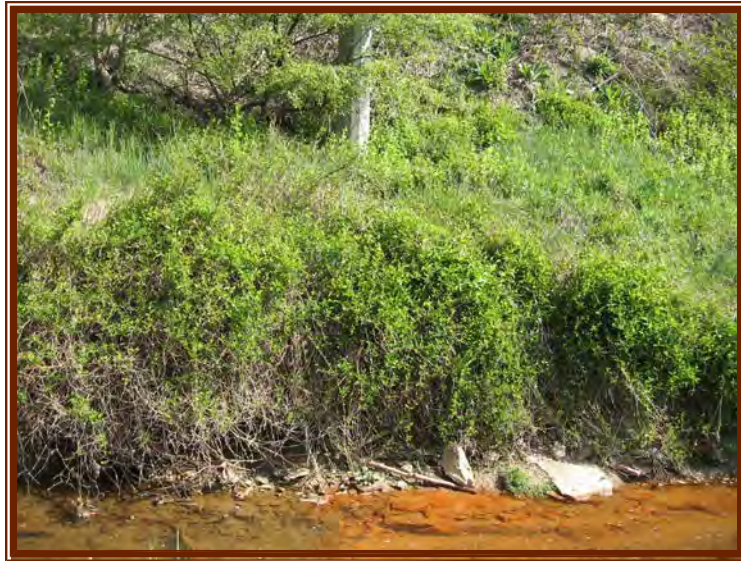
Source of AMD (CR-7 Photo 17)

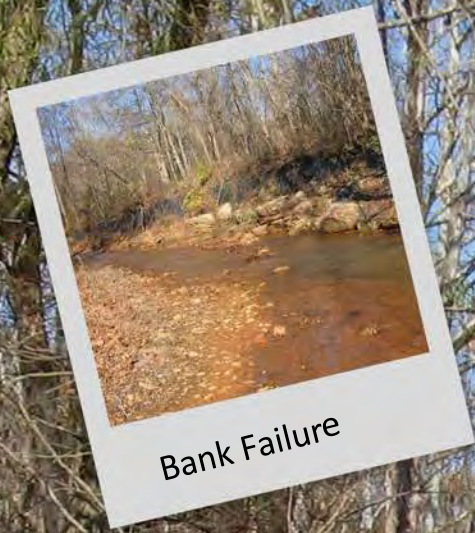
Bank Failure

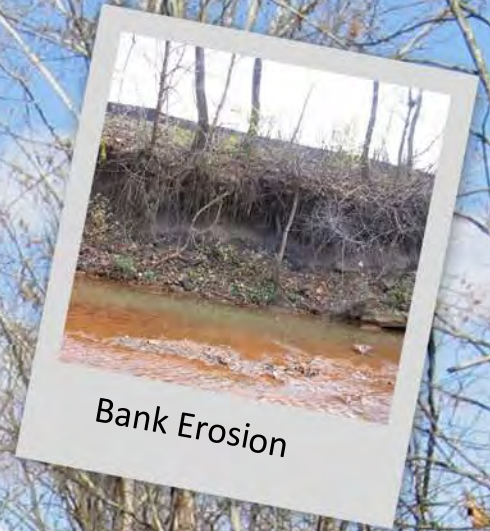
Bank Erosion

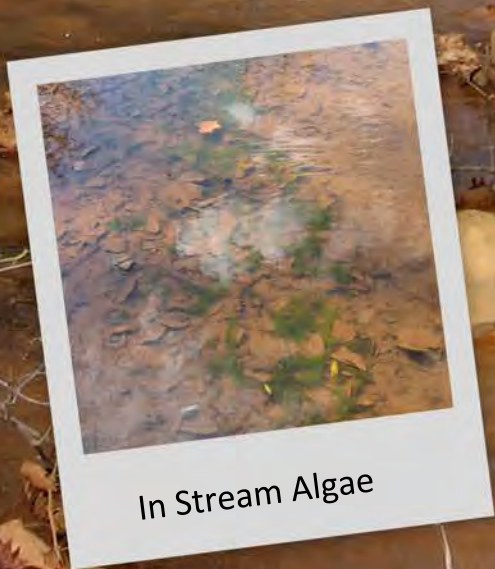
In Stream Algae

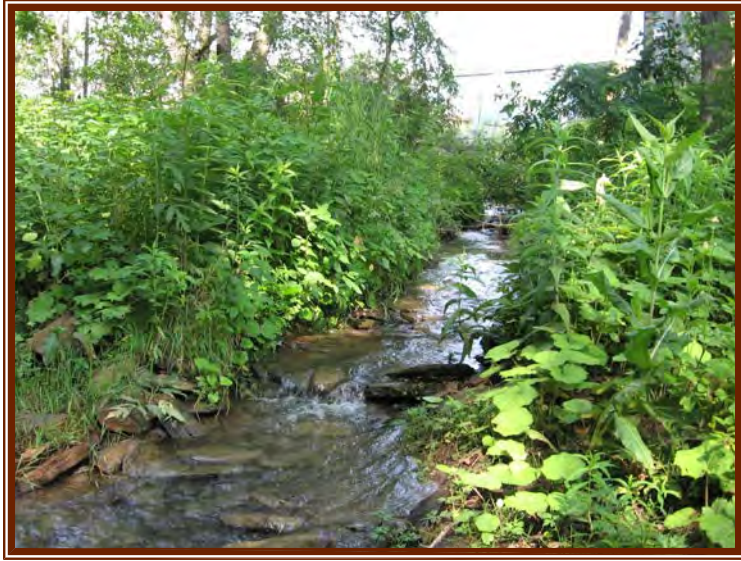
Fishing Run entering (MR-12 Photo 10)

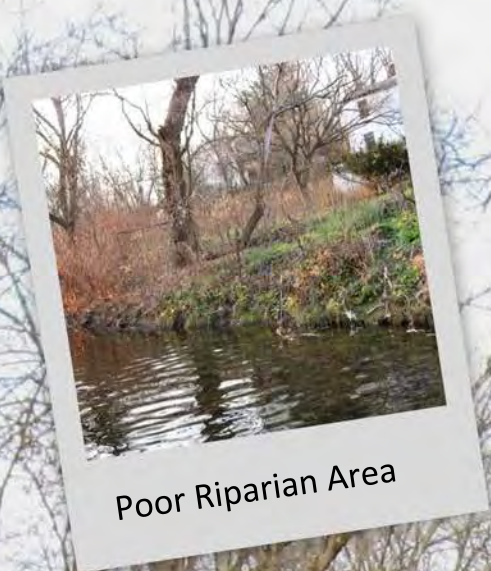
Poor Riparian Area

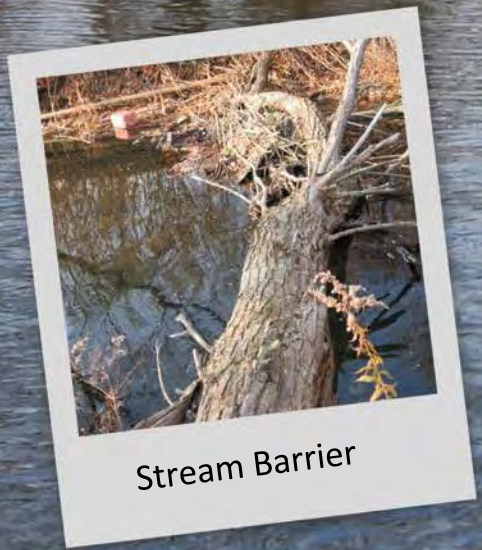
Stream Barrier

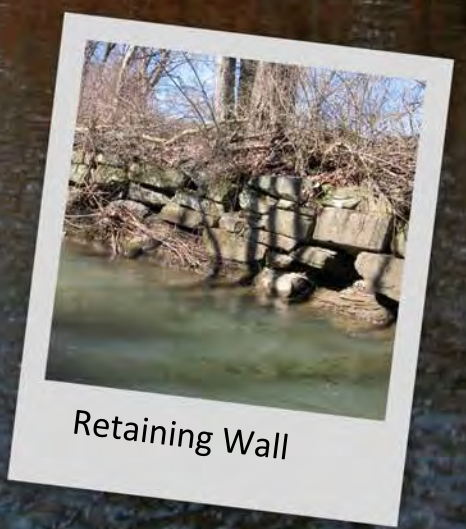
Retaining Wall

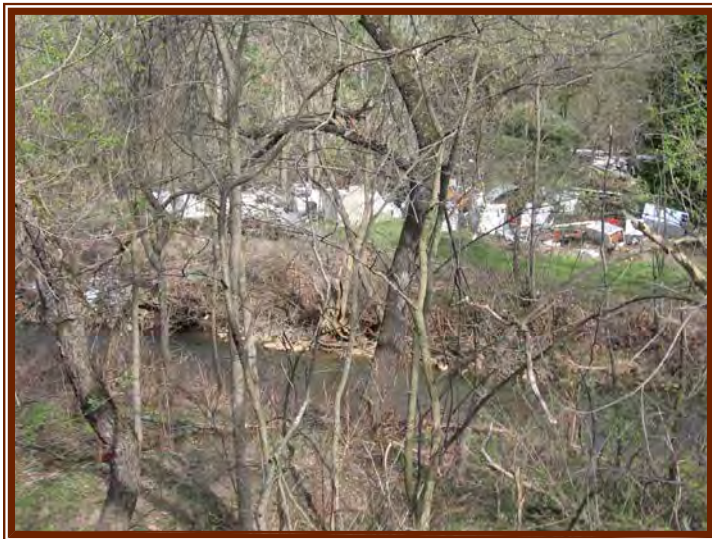
Trash (RR-7 Photo 5)
