East Branch Tionesta Creek

COLDWATER CONSERVATION PLAN

McKean, Warren, and Elk Counties

May 2017

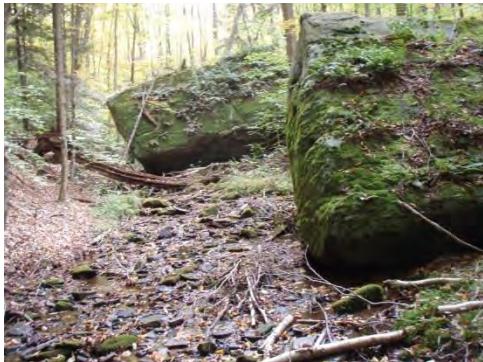
6006: Free flowing segment downstream of relic log RR boiler-fill pond.
